Intelsat Epic High-throughput Satellite Platform Interference Mitigation Testing

Interference Scenarios and Mitigation Techniques Enabled by the Intelsat Epic Class Satellites

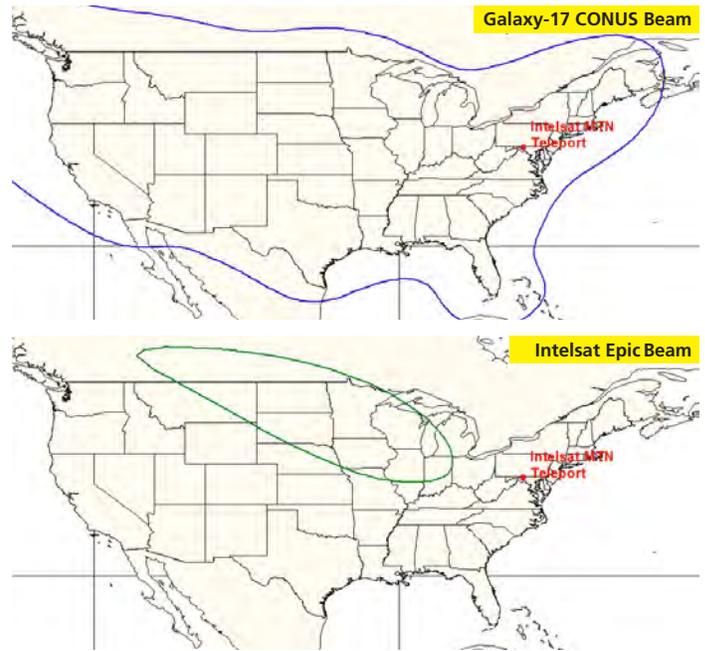
Fig. 1: Wide Beam versus Spot Beam Coverage Areas

In a multi-spot satellite, the coverage area of each spot beam is significantly smaller than the area of a traditional, landmass-shaped, wide beam. Figure 1 contrasts the CONUS (contiguous U.S.) wide beam coverage of Galaxy-17 (top) with the spot coverage on an Intelsat Epic satellite (bottom). This difference in coverage areas leads to the first interference mitigation tool provided by Intelsat Epic satellites, namely out-of-beam rejection.

The difference in coverage areas between a wide and a spot beam drastically restricts the locations from where an interferer can impact services. For the interference scenario described above and on the Galaxy-17 CONUS wide beam, an interferer could disrupt the friendly transmission from anywhere within CONUS.

The operational environment for this testing was a spot beam on an Intelsat Epic satellite configured in loop back. I.e. a signal uplinked in the coverage area was received by the satellite, routed onboard via the digital payload, and transmitted back to earth in the beam downlink. The Intelsat Epic satellite beam is shown in the lower half of Figure 1. The up and downlink frequencies were Ku-band.

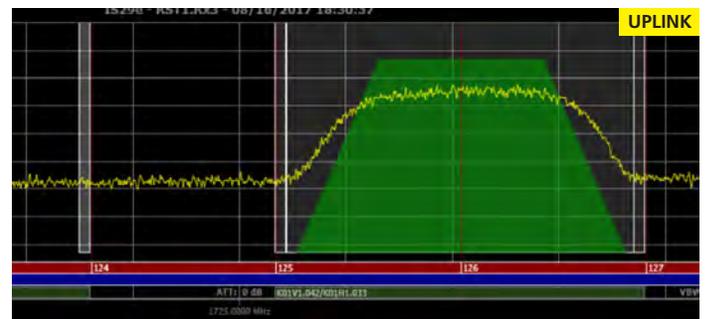
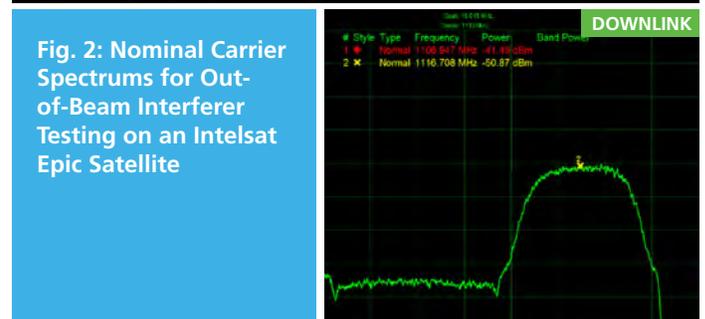
Fig. 2: Nominal Carrier Spectrums for Out-of-Beam Interferer Testing on an Intelsat Epic Satellite

Figure 2 shows the uplink and downlink spectrum of this testing. The Intelsat Epic satellite has an onboard spectrum monitoring system (SMS). Intelsat Epic satellites continually transmit their SMS data to Intelsat Operations for real time and archival uses. In Figure 2, the yellow line is the spectral power received from the spot beam. The green trapezoid in Figure 2 is an overlay from Intelsat's asset planning system and represents an approved and allocated carrier. The carrier shown is the remote-to-hub video carrier.

Figure 2 shows the downlink spectrum as received at the hub. Figure 2 was taken during nominal operations; the carrier was being properly received and the video quality from remote to hub was excellent.

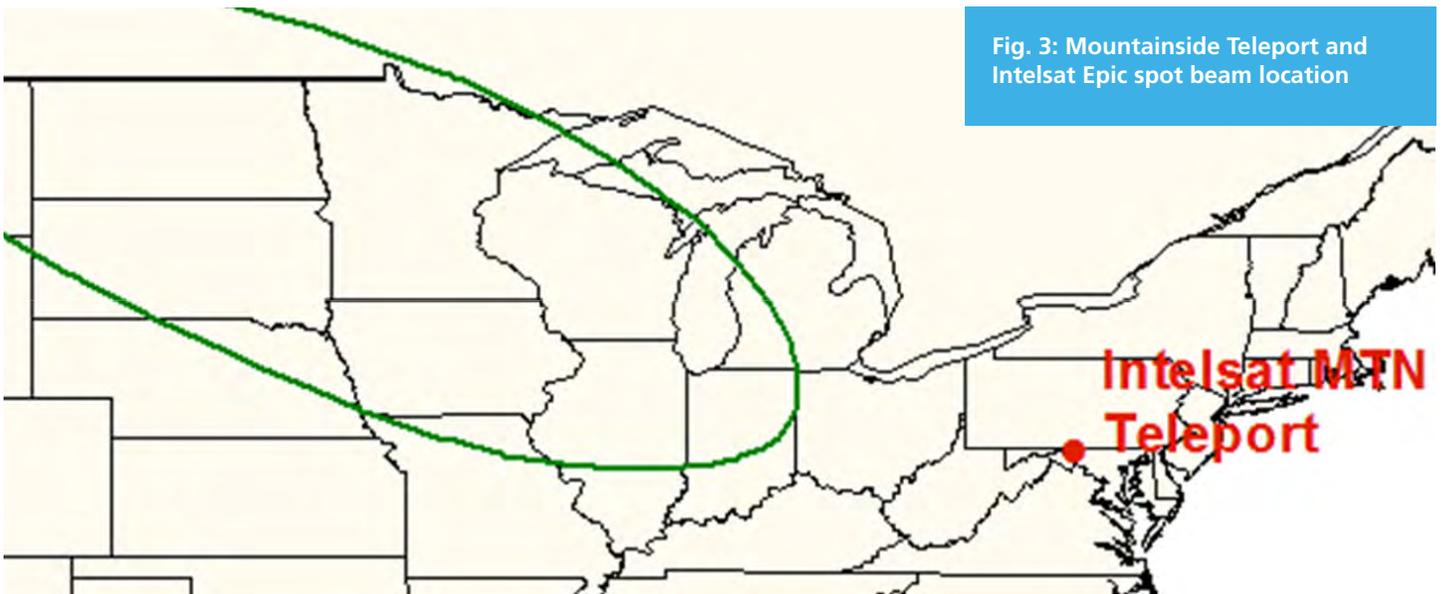
Fig. 3: Mountainside Teleport and Intelsat Epic spot beam location

To demonstrate out-of-beam interference mitigation, Intelsat’s Mountainside Teleport (MTN), located in Hagerstown, MD, transmitted an interferer that matched the friendly carrier. The locations of the MTN Teleport and the spot beam (nominal beam edge) are shown in Figure 3.

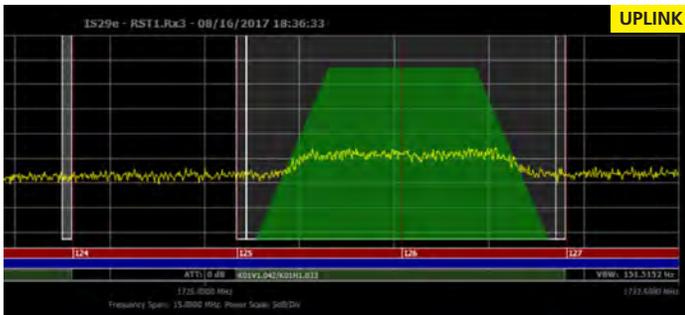
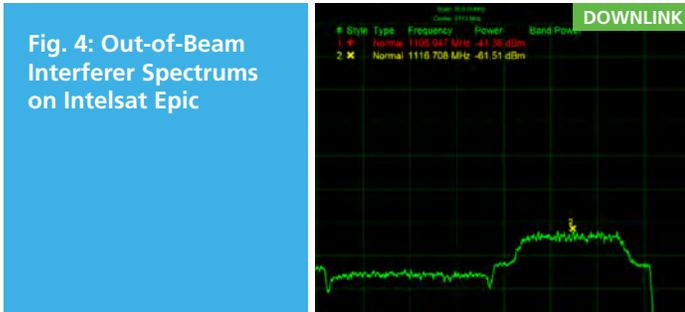
The MTN interferer matched the friendly carrier in size (symbol rate), modulation, and transmitted power level (EIRP). Since MTN is outside, but still close to, the coverage area, its transmitted signal was received by the satellite at a much lower level than the friendly carrier. Figure 4 shows the uplink and downlink spectrums of the interfering carrier (the friendly carrier has been turned off). Due to the out-of-beam location of the interferer’s transmission, its received power spectral density level at the satellite is approximately 12 dB below that of the friendly carrier.

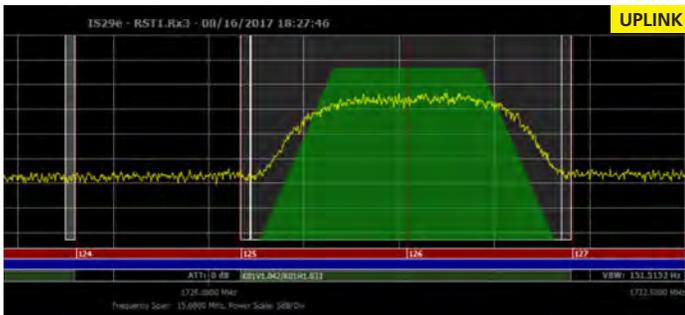
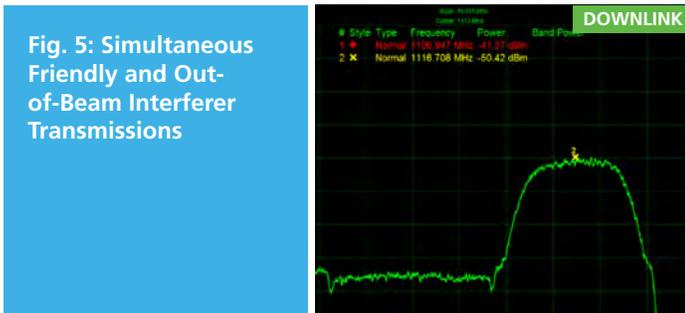
With both the friendly and interferer carriers transmitting, the uplink and downlink spectrums were as shown in Figure 5. Even with the transmission of an equal power interference signal, out-of-beam rejection was sufficient to enable excellent video reception at the hub. Received video quality was the same as with no interferer present.

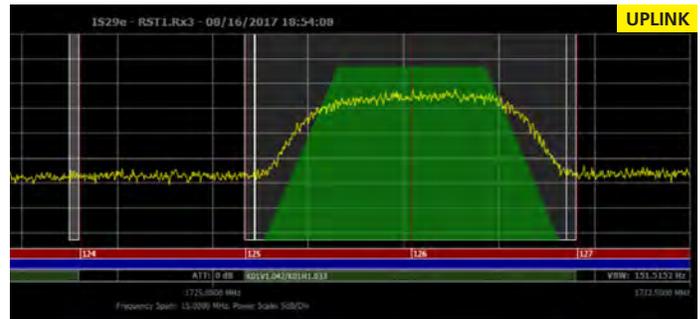
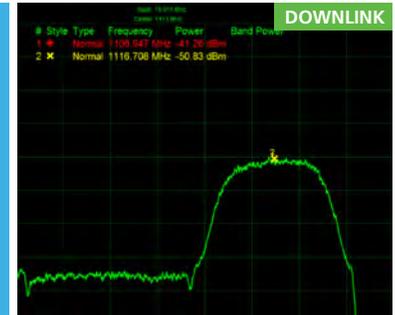
Fig. 6: Nominal Uplink & Downlink Spectrums for In-Beam Interferer Testing

To create an in-beam interferer, we transmitted a matched carrier from the hub location. This carrier was separate from, and in addition to, the remote-to-hub video carrier. At the start of this test, the video carrier was as shown in Figure 6. This is identical to the start of the out-of-beam interferer testing, i.e. Figure 2. As before, in this mode, the video signal was properly received at the hub and video quality was excellent.

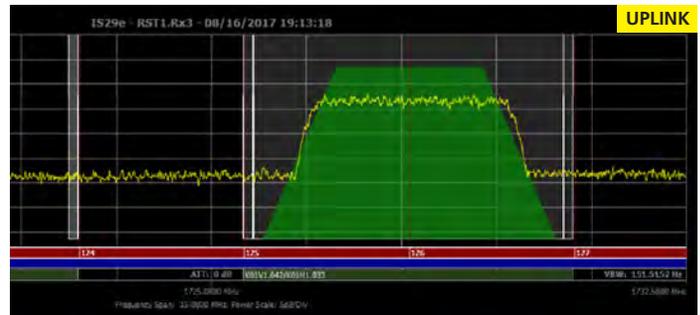
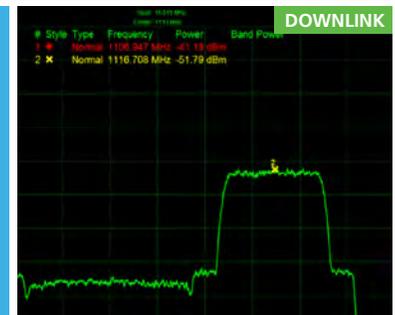
Fig. 7: In-Beam Interferer Only Spectrums

Figure 7 shows the spot beam's uplink and downlink spectrums with just the interferer carrier present (the video, aka friendly, carrier has been turned off). Note that a different modulator type, one with a tighter carrier roll-off, generated the interfering carrier and thereby created a sharper carrier spectrum.

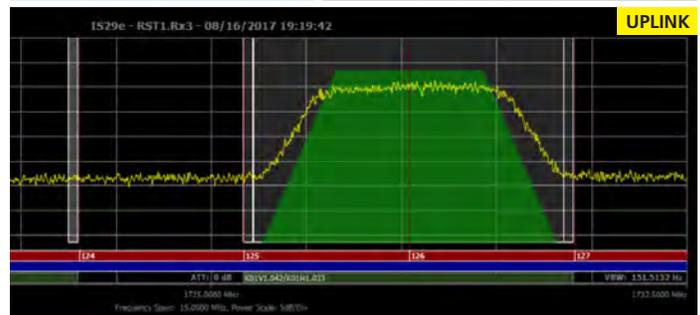
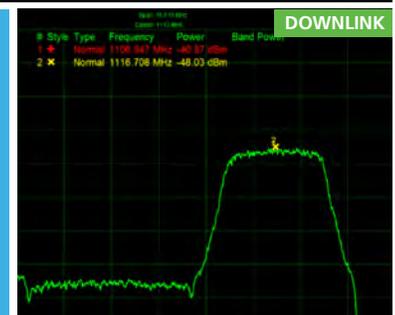
Fig. 8: Simultaneous Friendly and In-Beam Interferer Transmissions

Simultaneous transmissions of friendly and interferer carriers are shown in Figure 8. In this scenario, video reception at the hub was not possible. i.e. the friendly carrier was successfully jammed.

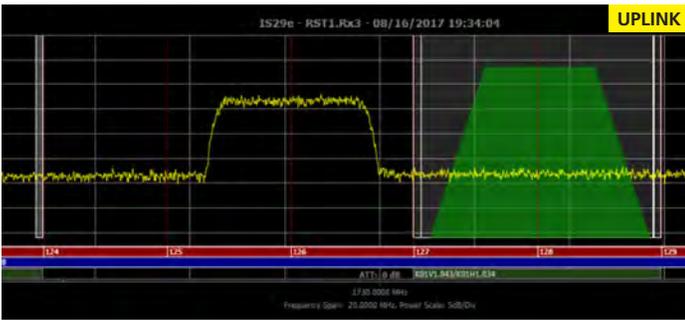
Fig. 9: Reconfiguration to Terminate Interferer & Reallocate Friendly Carrier

Figures 9 through 11 visualize the sequence of steps taken to counter the in-beam interferer. In Figure 9, satellite reconfiguration is underway.

The video carrier’s uplink bandwidth has been reallocated to avoid the interferer. The new allocation is the green trapezoid. Transmission of video carrier at the new allocation has not yet started.

The interfering carrier is still transmitting but the uplink bandwidth it occupies has been deallocated on the satellite. As such, this uplink bandwidth is no longer routed onboard to a downlink path and, thereby, is terminated at the satellite. I.e. the interferer is no longer corrupting the satellite’s transmissions back towards earth.

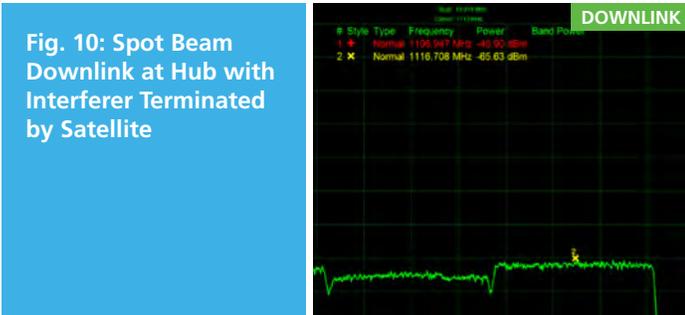
Fig. 10: Spot Beam Downlink at Hub with Interferer Terminated by Satellite

Figure 10 shows the downlink (received at the hub) where the interferer has been blocked; aka has been “notched out.” The friendly video transmission has not yet restarted.

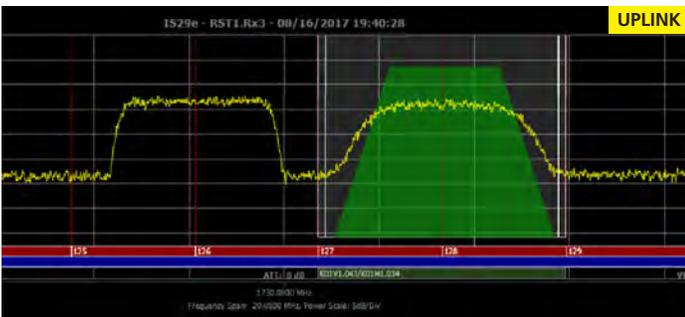
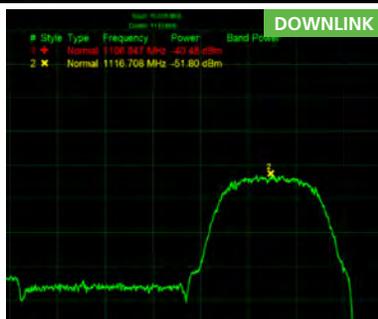
Fig. 11: Intelsat Epic Satellite Reconfigured to Terminate Interferer & Reallocate Friendly Carrier

With the video transmission re-started, Figure 11 shows both the friendly and interfering uplinked signals (top) and the Intelsat Epic’s clean downlinked signal (bottom). At this point, successful video transmission has been re-established.
